BMW CONCESSIONAIRES G.B. LIMITED

Service - Information

BMW CONCESSIONAIRES ENGLAND LIMITED

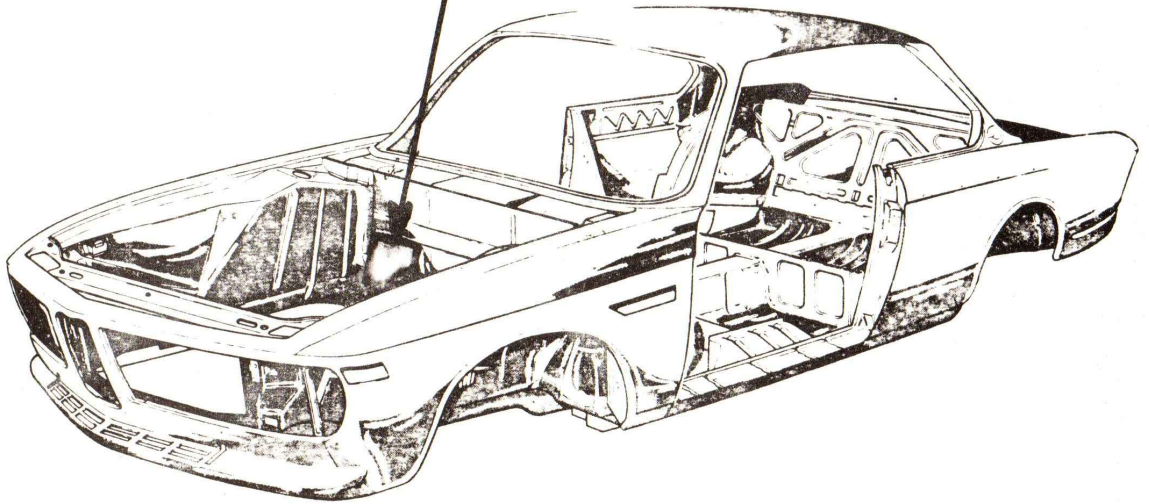
As the exhaust flange is very near to the Rubber insulations on the engine side of the Bulkhead, it is necessary to remove a section of this insulation:- we would suggest removing section illustrated, from Throttle Rod downwards on the offside as indicated on the attached drawing.

REMOVED THIS SECTION OF RUBBER INSULATION.

This must be carried out on all 2.8 Coupes as soon as possible.

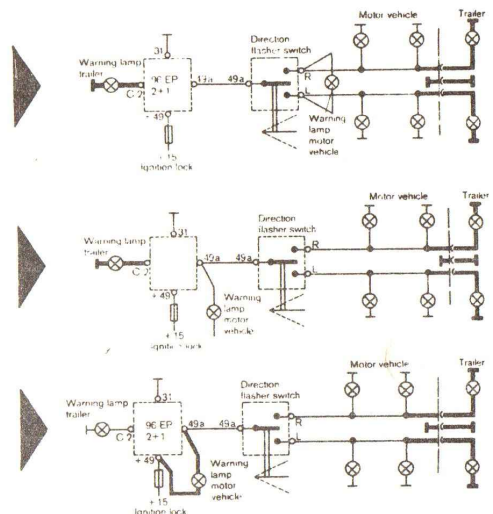
Connect existing warning lamp to terminal C2. This will be used in future for the trailer flasher lamps.

For the flasher lamps on motor vehicle, install a new warning lamp and connect between terminal 49a and +15 or +49 of flasher unit. The warning lamp should be insulated to prevent its coming into contact with the vehicle.

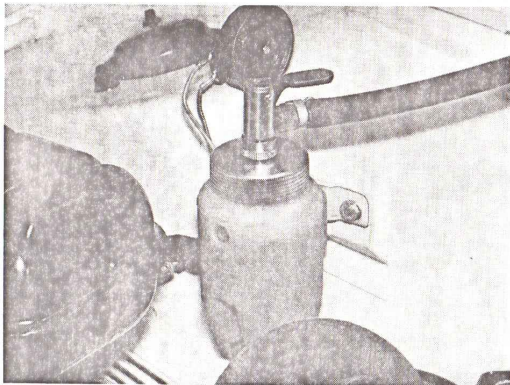
Commencing - bleed both Servo Nipples.
Bleed 'A' Nipples N/S/F and O/S/F.
Bleed rear brakes - furthest point first.
Return to front - bleed Nipples (photo B) both sides, then bleed both Nipples 'C'.
When all air is extracted - without running engine - press brake pedal several times; click in Servos should be heard.
It is advisable to release vacuum pipe from engine when operation is complete. Check for brake fluid leakage.
