# SERVICE INFORMATION

BMW 2500 - 2800  
Gr.: Body and Fittings

München, June 1970  
nr. 9/68 (478) en.

Re: Safety belts

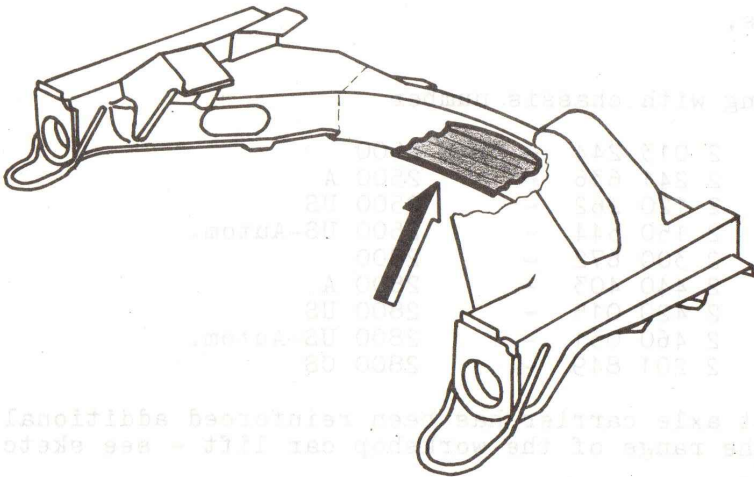
The front axle carrier has been reinforced additionally within the range of the car lift - see sketch overleaf.

On this version it is no longer absolutely necessary to jack up with the hitherto prescribed device for the front axle carrier. We recommend, however, to modify the two outer kick-up profiles of the device so that these may be re-adjusted.

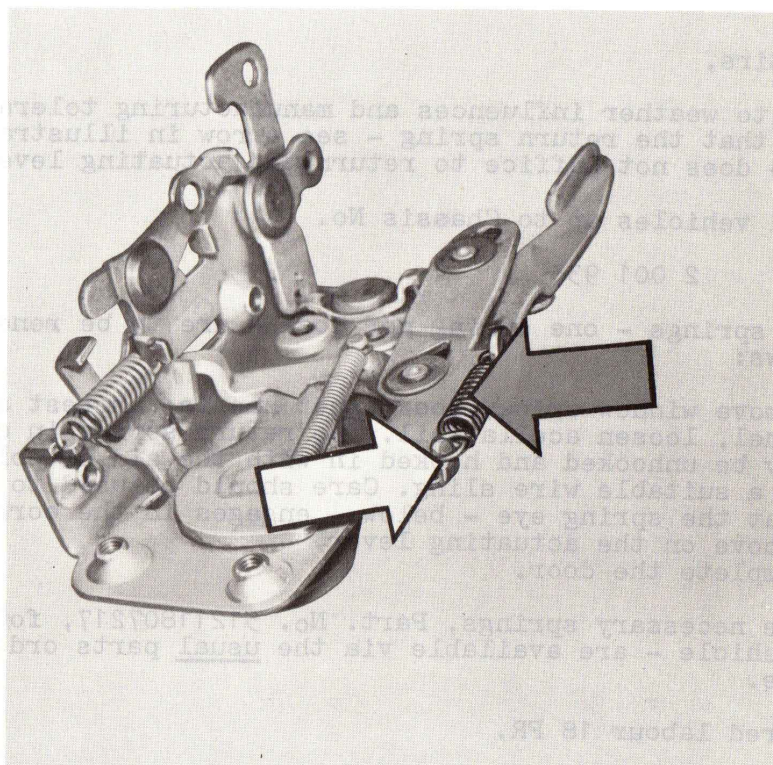
Illustration on overleaf

Owing to weather influences and manufacturing tolerances it may occur that the return spring - see arrow in illustration on overleaf - does not suffice to return the actuating lever.

these springs - one spring per lock - are to be renewed as follows:

Remove window crank, door inner handle, armrest and trim panel, loosen acella foil. The return spring in question may be unhooked and hooked in with the aid of pointed pliers or a suitable wire sling. Care should be used to assure that the spring eye - below - engages in the corresponding groove on the actuating lever.  
Complete the door.

The necessary springs, Part. No. 51211807217, four pieces per vehicle - are available via the usual parts ordering procedure.

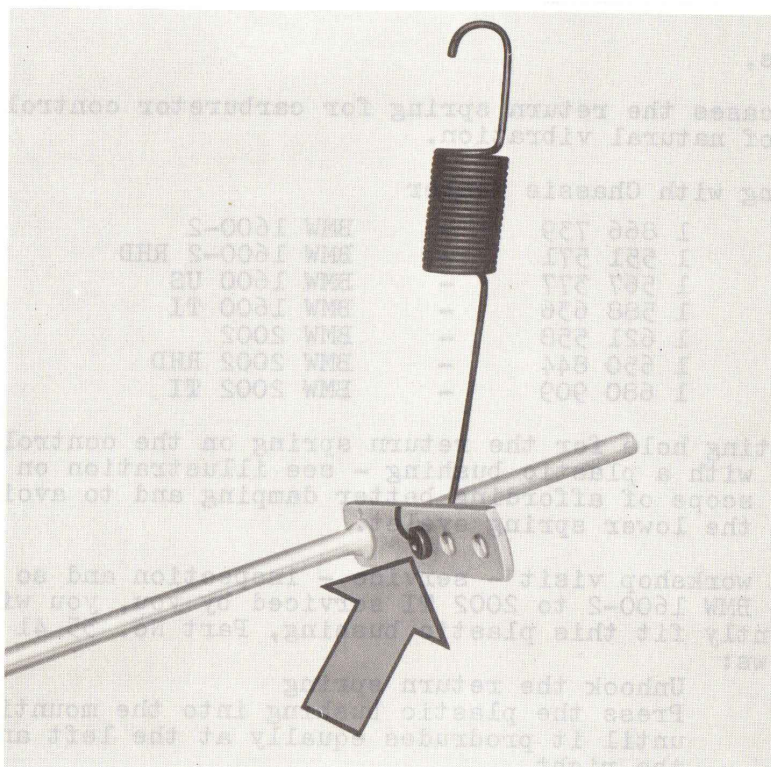
Illustration on overleaf

In some cases the return spring for carburetor control has broken because of natural vibration.

the mounting hole for the return spring on the control lever is equipped with a plastic bushing - see illustration on overleaf - with the scope of affording better damping and to avoid chafing spots on the lower spring eyelet.

During a workshop visit - service - inspection and so on of the vehicles BMW 1600-2 to 2002 TI serviced by you, you will, please, subsequently fit this plastic bushing, Part No. 35 41 1 103 614, as follows:

Unhook the return spring  
Press the plastic bushing into the mounting hole  
until it protrudes equally at the left and at  
the right  
Reinstall the return spring

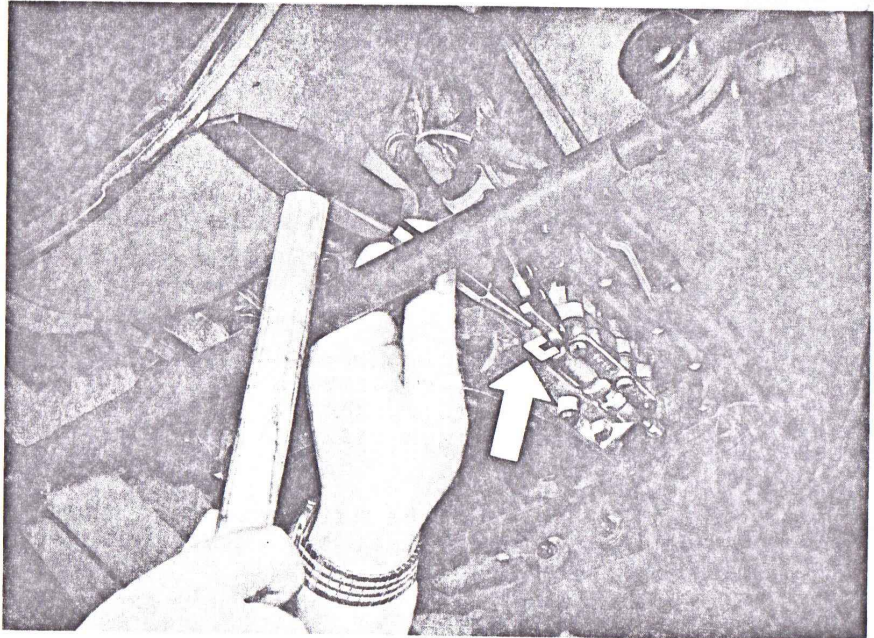
(Illustration)

For safety reasons it is necessary to check all automatic transmissions with the numbers 25587 to 28786 (stamped on the gear box at the rear, above the oil pan) about irreproachable condition of the selector slide on the selector unit.

If a defective tight fit of the guide piece on the slide piston is stated, the selector unit must be removed and reinstalled following the instructions in the Repair Manual BMW 1500 - 2000, group: transmission, page GA 14 to GA 15 and the selector slide must absolutely be renewed.
