SERVICE INFORMATION

München, April 1969
No. 2/69 (517) en.

RE: Adjustment of the throttle linkage

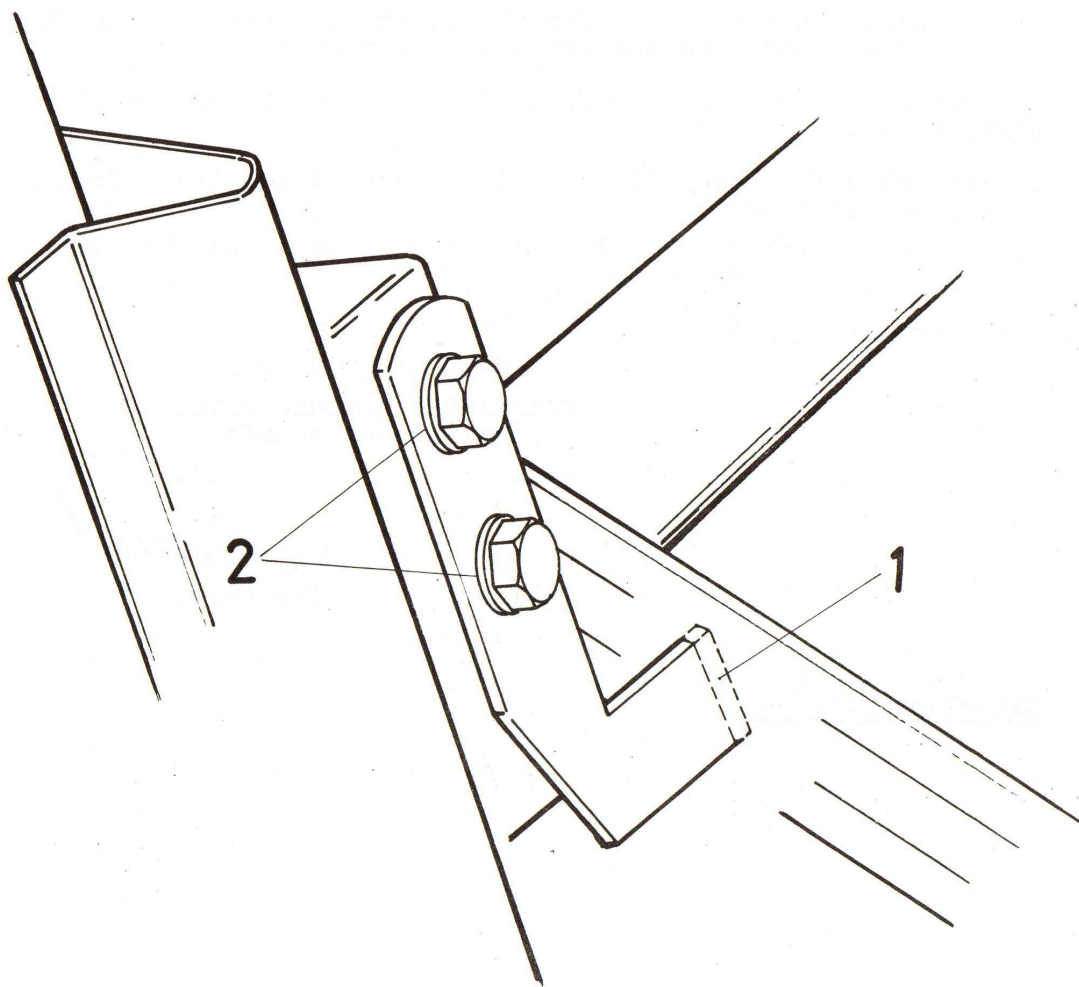
it may occur that the stop for the front lid support at left touches the battery as the front lid is closed.

- 1) File down the stop (1) so as to prevent the battery from any touching or
- 2) Rework the holes (2) with a file so as to allow the stop to be shifted more outwards.

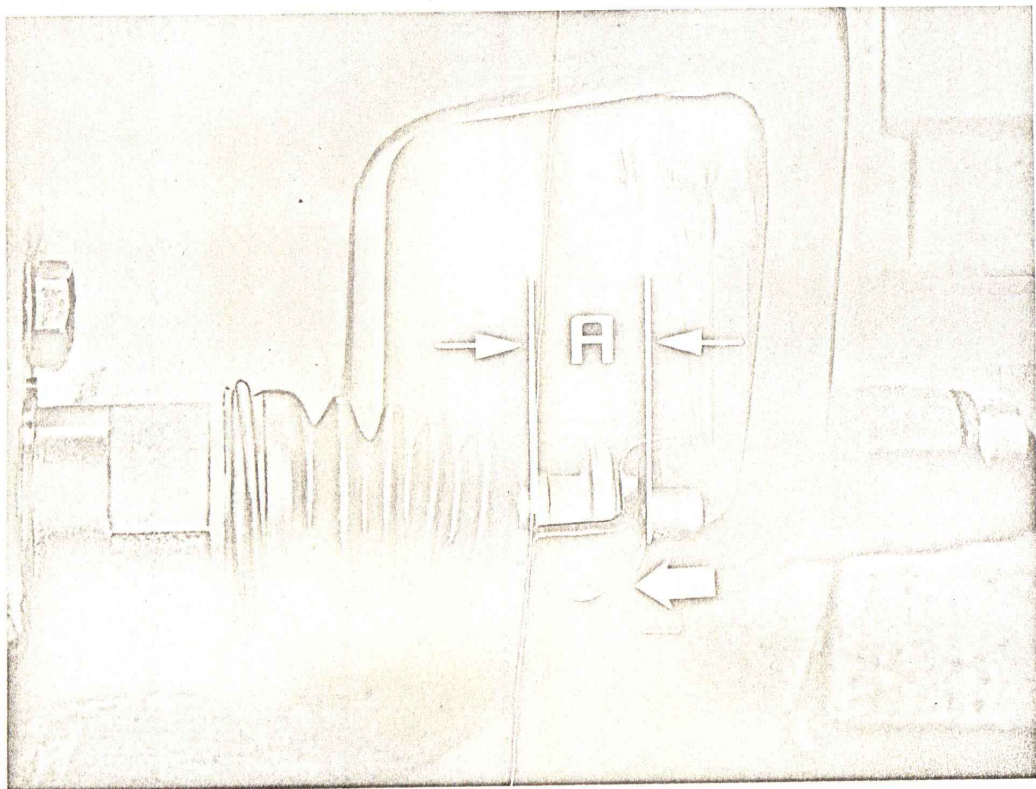
Push the release lever by hand into driving direction till the stop of the clutch slave cylinder. In new condition the measured travel on the push rod A amounts to 17 to 19 mm, see figure.
As the wear of the clutch disc increases, the distance A decreases and when it reaches a minimum of A = 5mm the clutch disc is to be replaced.

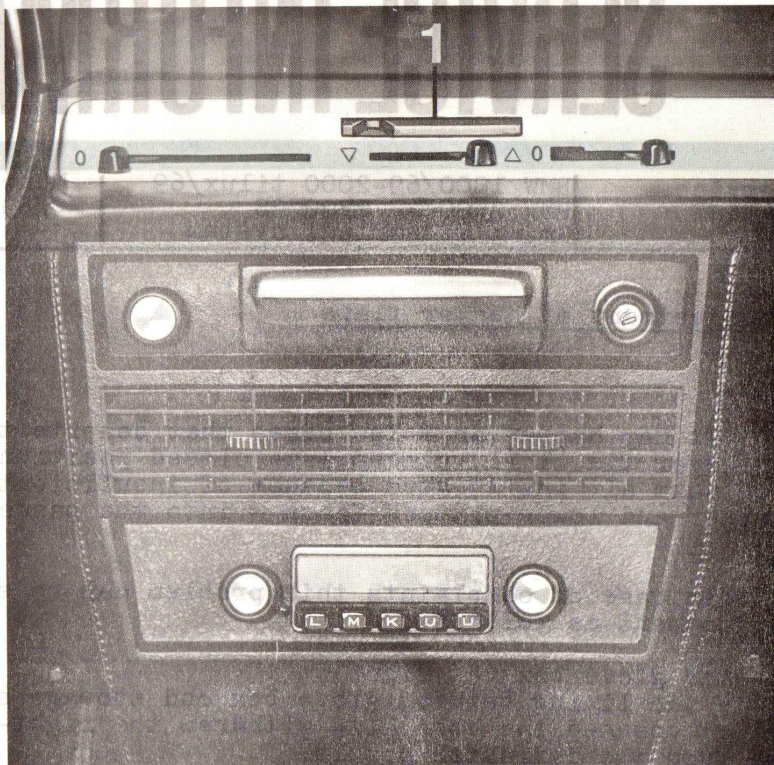
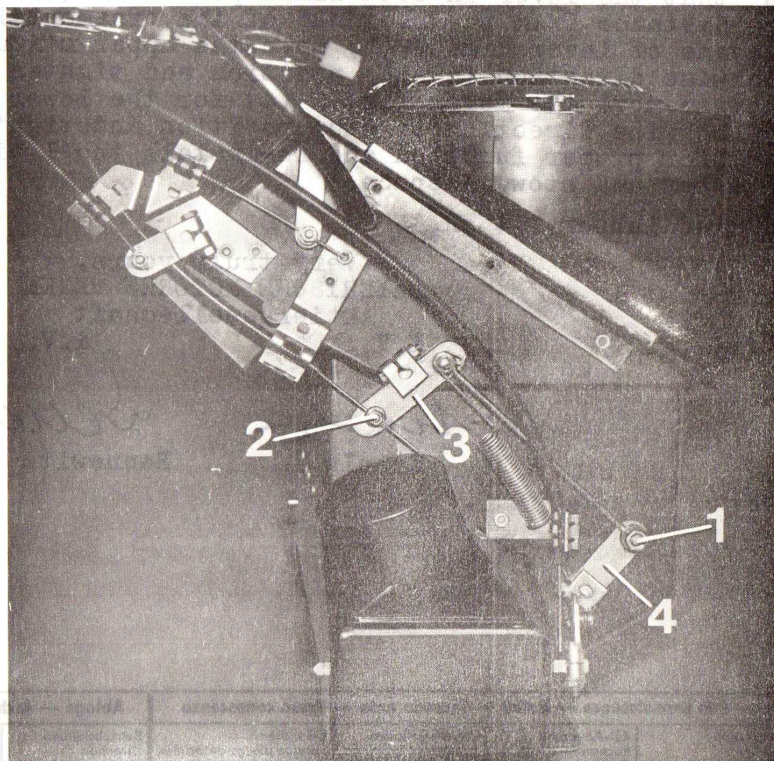
It may happen in a few cases that despite temperature selector lever fig. 1 (1) placed into closed position, a small amount of warm air infiltrates because of insufficient flap adjustment - upper and lower mixture flaps - into the passenger compartment.

1. Open the glove box (at right).
2. Remove the lining between glove box and stowage space.
3. Having loosened the hose clip withdraw the right-hand defroster hose from the defroster nozzle.
4. With the aid of an SW 10 spanner slacken the screw fig. 2 (1) on the connecting linkage.
5. Loosen screw fig. 2 (2), adjust temperature selector lever so that the lever in both final positions (warm-cold) has the same distance from the slot end of the ornamental screening.
6. By means of lever fig. 2 (3) move the upper mixture flap in clockwise direction to stop position and tighten screw (2).
7. Likewise move the lever fig. 2 (4) for the lower mixture flap in clockwise direction to stop position and tighten screw. (1)
8. Check for proper function and re-install the lining between glove box and stowage space.
