| Service - Technical VS-2010 wk/mk/fm | BMW 2002 turbo Group: Engine | Munich, May '75 11 07 75 (962) e |

Re: Engine - BMW 2002 turbo

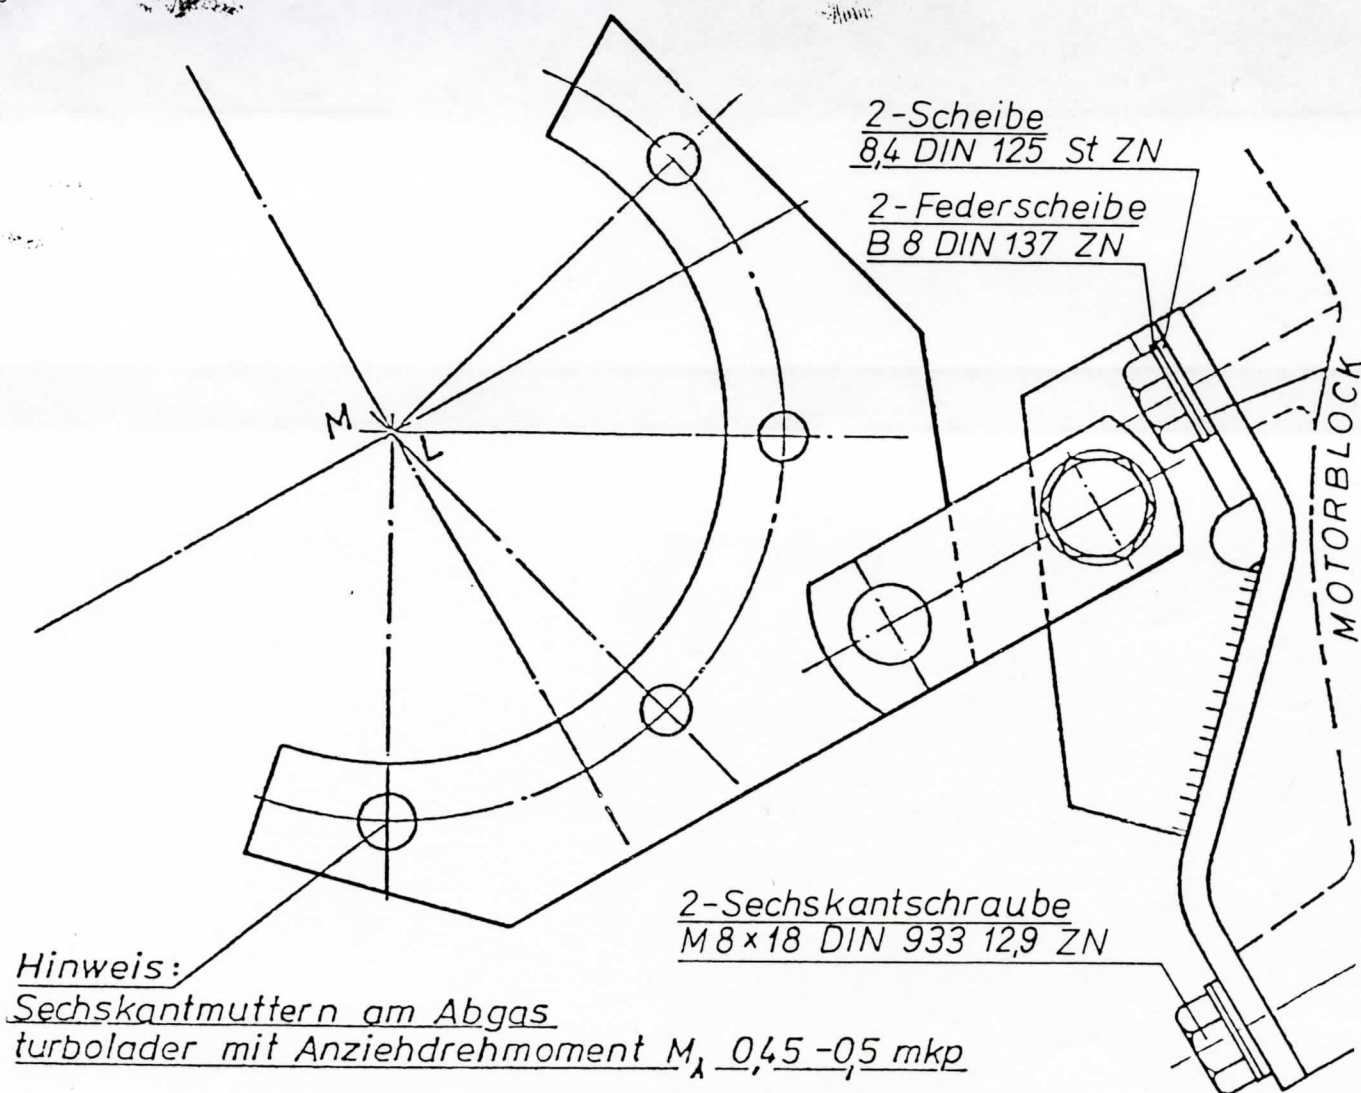
- e) Loosen exhaust manifold only "slightly" and tighten it following Point 2, having it adjusted with centering sleeves.
- f) Remove two locking plates from the turbocharger and transfer the remaining two locking plates by one bore, if required, and install the support plate according to Ill. 1 (tightening torque of M6 nut: 3.25 ... 3.6 ft.lb./0.45 ... 0.5 mkp).

- g) Fasten the support angle at the crankcase as shown with slightly tightened hex bolts (M8 x 18). In this position, which is correctly aligned but still movable over the throughbores, the support angle and support plate must be tightly connected with bolts via the cover plate (tightening torque 15.9 + 1.45 ft.lb./2.2 + 0.2 mkp). Now tighten the support angle to the crankcase (26.04 + 2.89 ft.lb./3.6 + 0.4 mkp).

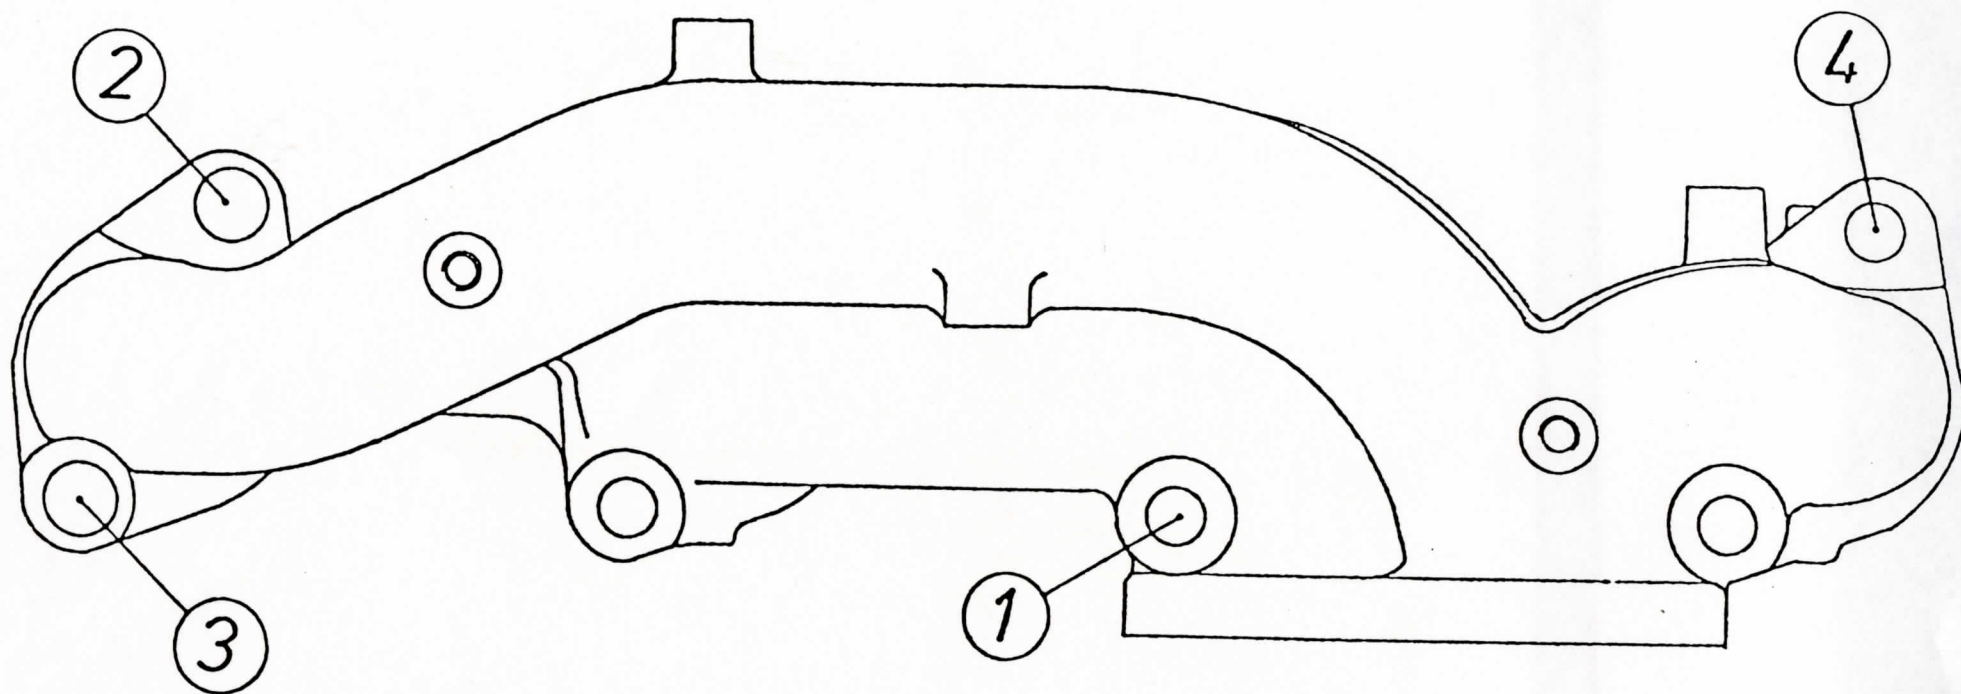
Due to the high thermal expansion of the exhaust manifold the bore holes have different diameters (0.43 in/11 mm, 0.47 in/12 mm, 0.51 in/13 mm). In order to guarantee an exact position of the manifold in relation to the cylinder head, the mounting should be accomplished with two mounting sleeves (Special Tool No. 11 60 20); see Ill. 2.

As soon as the gaskets and the exhaust manifold as well as the hex nuts are partly mounted to the stud bolts, set up first a centering sleeve at the lower stud bolt of cylinder "two" (Pos. 1), pressing it in by hand. Now set up the second centering sleeve at the upper

stud bolt of cylinder "four" (Pos. 2), pressing it in by hand. The two diagonal hex nuts (Positions 3 and 4) are now tightened which will hold the exhaust manifold in place so that the centering sleeves may be removed and the assembling continued as usual.
