Replacing the Fuel Sender Tube Sleeve

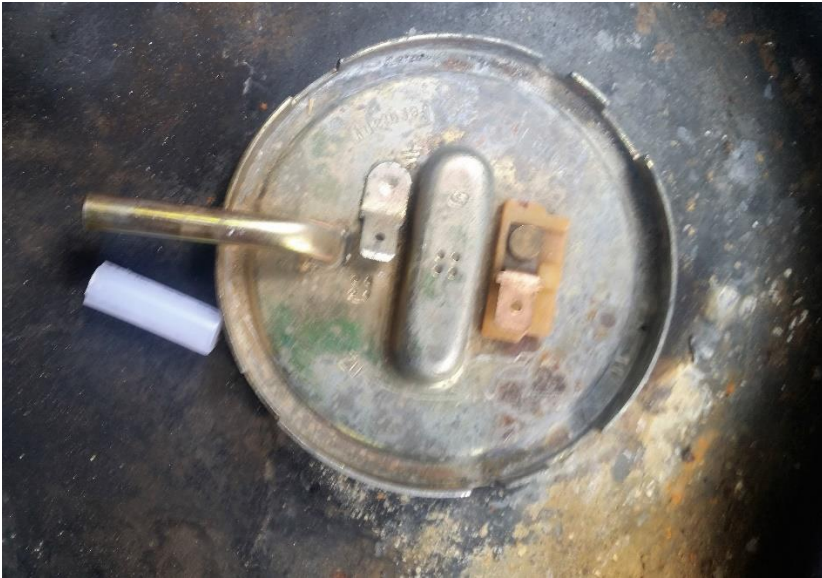
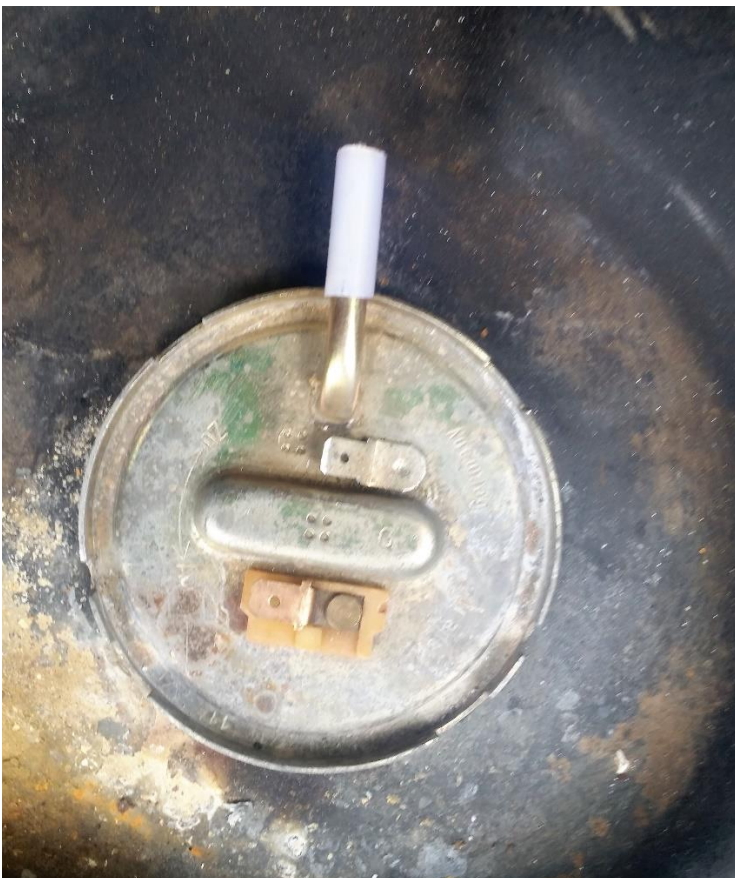
Over time the fuel sender tube sleeve deteriorates allowing gas to leak into the car. Or, more often than not, it was not replaced when new fuel hose was installed because a new one wasn't available.

It is simple to replace. Remove the fuel hose from the sender tube, remove the old sleeve if it is still there, and slid the new one onto the filler tube. Re-install the fuel hose and voila! One more source of gas smell eliminated.
