2002s  
—ONLY—

## Replacing the Fuel Sender Tube Sleeve

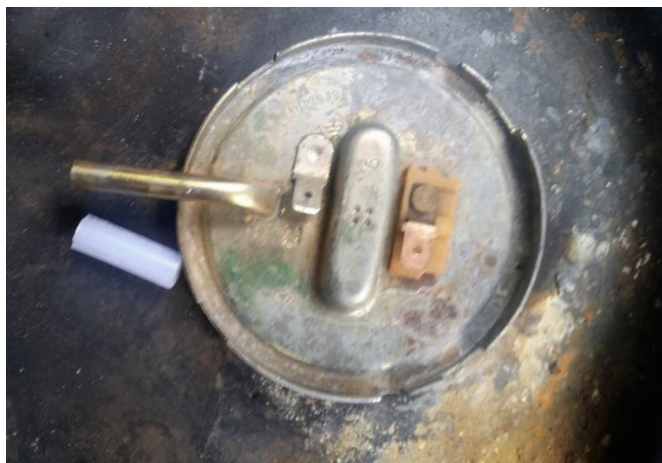
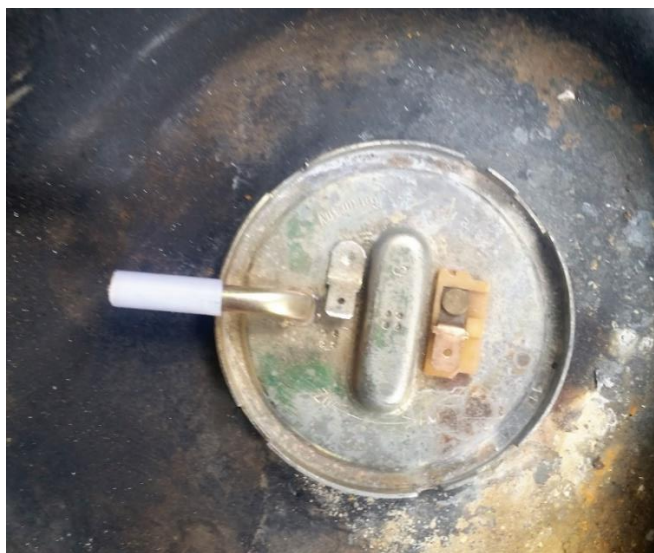
It is simple to replace. Remove the fuel hose from the sender tube, remove the old sleeve if it is still there, and slid the new one onto the filler tube (you might need to lube the tube with some oil as it is a tight fit). Re-install the fuel hose and voila! One more source of gas smell eliminated.

BTW, this is a tight fit. You might need to dress the tube with some fine grit sandpaper and use some lubricant to slide it on.

Over time the fuel sender tube sleeve on the 2002s deteriorates allowing gas to leak into the car. Or, more often than not, it was not replaced when new fuel hose was installed because a new one wasn't available.
