[BMW 2002 FAQ Forum Index](#) > ['02 General Discussion](#)Jump to: < [Prev. Topic](#) :: [Next Topic](#) >Thread Topic: [Cylinder head oil leak](#)

From: doug73cs in Canmore [profile](#)Subject: Cylinder head oil leak [reply](#) [quote](#)

I'm going to try to fix the oil seepage at the cylinder head gasket with RTF. Re-use the gasket (8,000mi on it) and bolts or splurge on new ones? Guessing the answer but always optimistic.

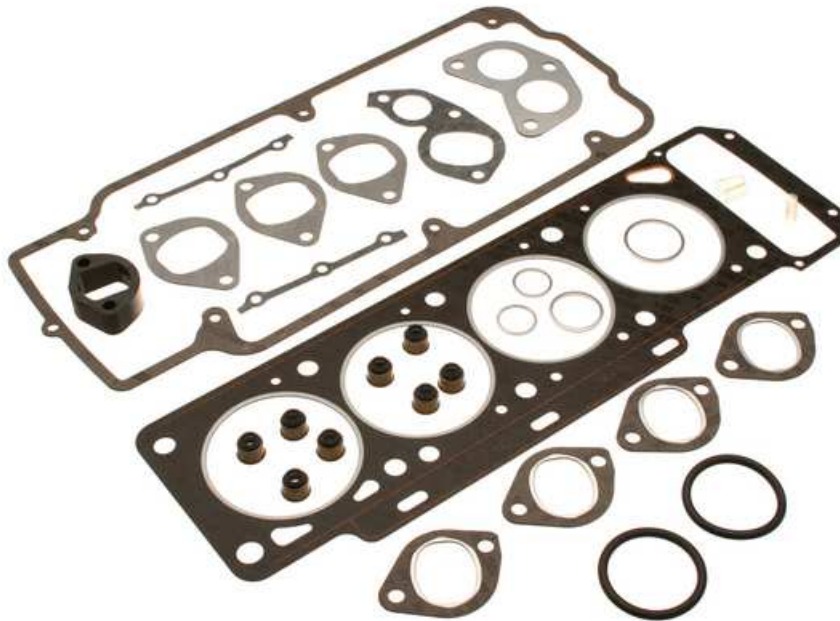
The newer headgaskets have this bead that goes all the way around to prevent this BTW.

You can see it in this worldpac pic... (Autopartways.com)

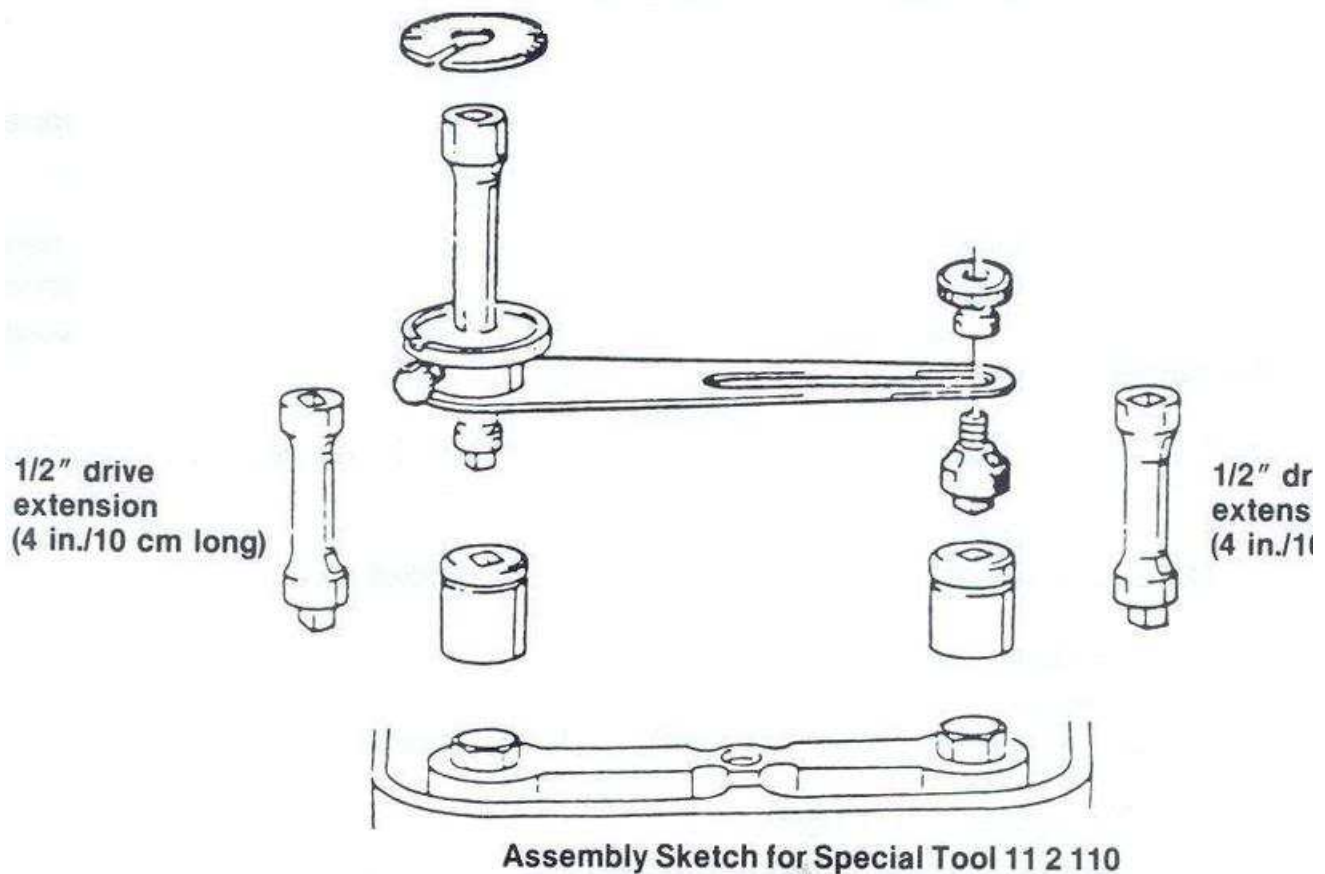
Handling and Application of Special Tool 'TORQUE ANGLE TIGHTENING

A special tool attachment, which can be combined with the special tool No. 11 2 110) for tightening connecting rod bolts, was developed in order to precisely tighten cylinder head bolts with the specified torque angle.

To tighten cylinder head bolts with the final value, the tool must be used each time that the second socket rests on the opposite cylinder head. In the case of unfavorably located cylinder head bolts (e.g. on firewall), 4 cm long 1/2" extensions must be used. In unloaded state turn graduated dial to 0° and lock with the knurled head screw.

Cylinder head bolts are tightened until the mark points to the specified value in the table (bolts tightened in proper sequence).

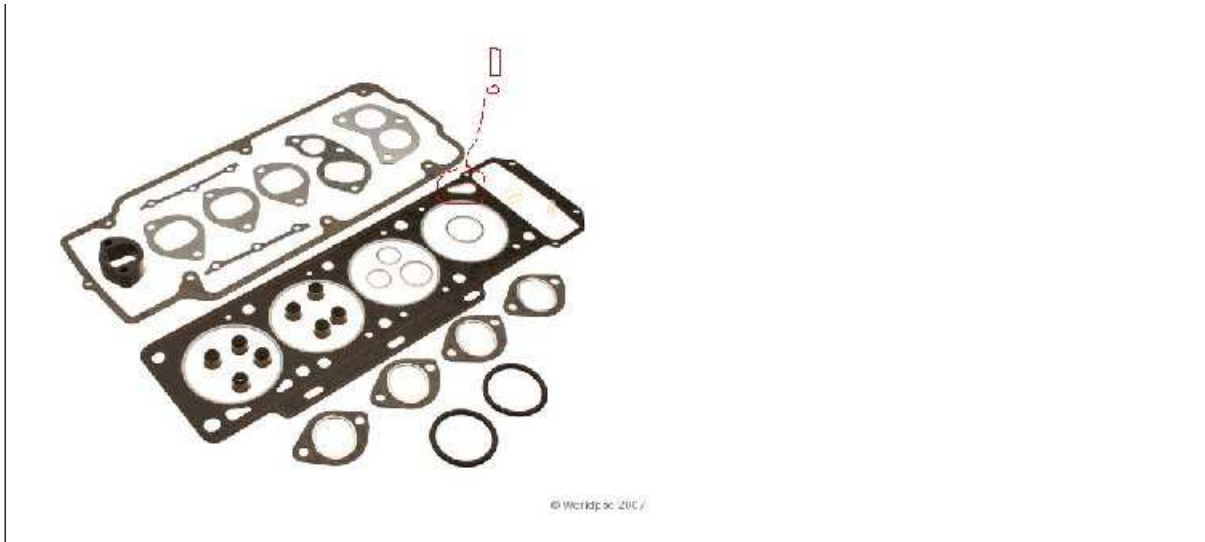
| headgasket.jpg | |

Here's the only high pressure oil spot-

if it's coming out of the front upper corner, this is where it'd come from.

Yup, that's where I think it is coming from. Is trying to seal the front timing case a waste of time? It could originate under the head and be forced out under the timing chain cover.
