| Service - Technical VS-2010 wk/mk/fm | BMW 2002 turbo Group: Engine | Munich, May '75 11 07 75 (962) e |

Re: Engine - BMW 2002 turbo

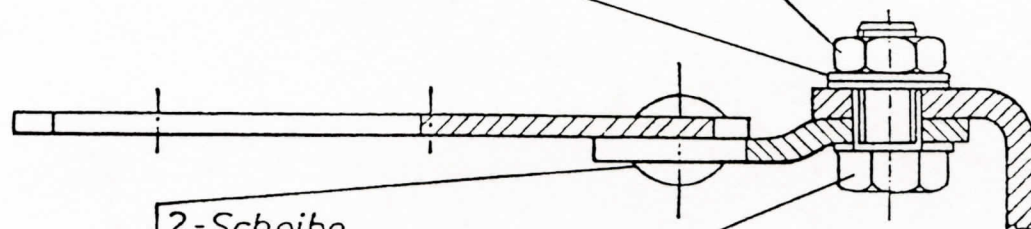
Sechskantmutter
M 8 DIN 934 - 8 ZN

Federscheibe
B 8 DIN 137 ZN

Sechskantschraube
M 8 x 20 DIN 933 18.8 ZN

(Anziehdrehmoment 22^{+92} mkp)

- e) Loosen exhaust manifold only "slightly" and tighten it following Point 2, having it adjusted with centering sleeves.
- f) Remove two locking plates from the turbocharger and transfer the remaining two locking plates by one bore, if required, and install the support plate according to Ill. 1 (tightening torque of M6 nut: 3.25 ... 3.6 ft.lb./0.45 ... 0.5 mkp).
