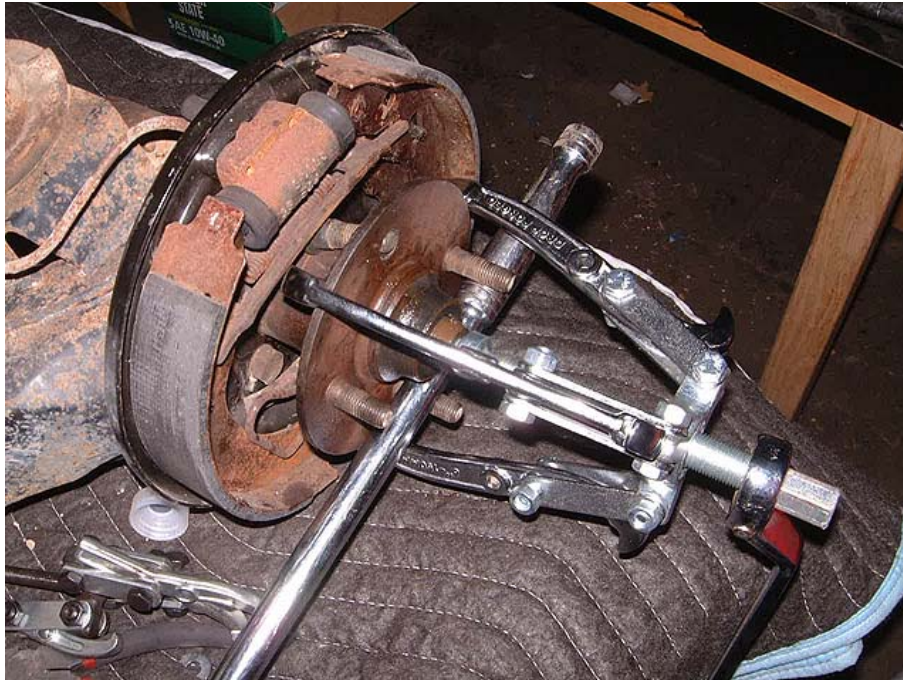
Sneak peak at next month's work: There was one right rear hub really frozen to the stub axle. I'm quite sure it hasn't been off the car since 1974. The two have been separated now from birth with the help of a wheel puller and an 8 lb sledge hammer. These will be powder coated and new hardened wheel studs installed. TII NOTE: Little known fact, but these rear hubs is an NLA part, they are hardened on TIIs to be stronger. A part worth obtaining for other upgraded 02's if you find a parts car.

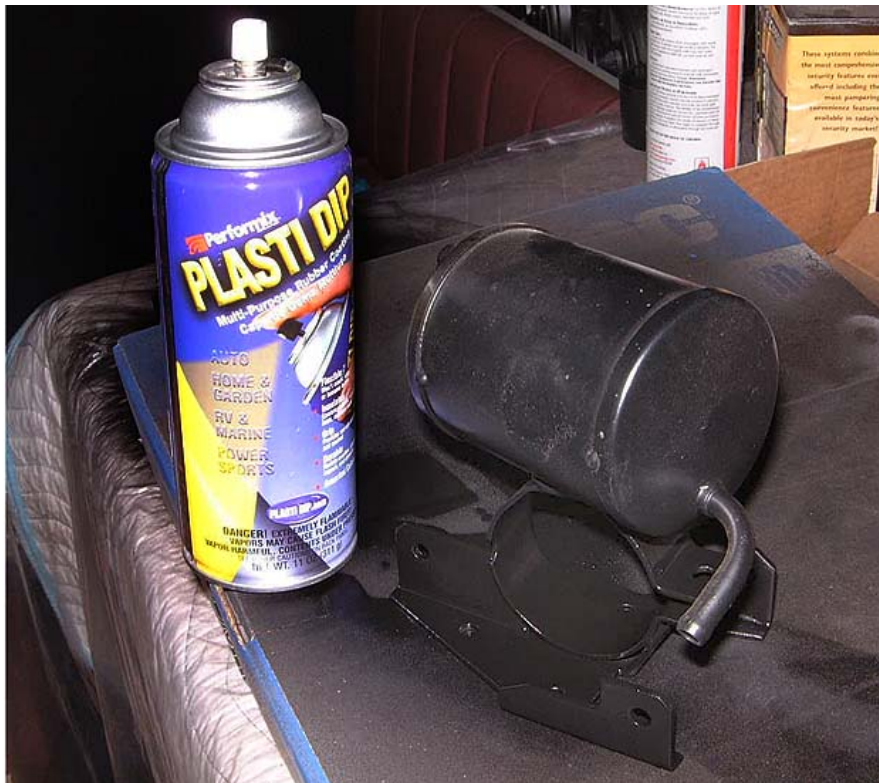
PROTECTION AGAINST MOTHER NATURE: I've obtained a new fuel canister for the rear of the car since they can get quite crusty over the years. My past ventures with the fuel system (see [HOW-TO](#)

SECTION for the fun details) taught me in a hurry this is something you want to keep as new as possible for as long as you can. So I chose the same route taken with the fuel line setup from last month. I chose Plasti-Dip Black in spray can size. This is cool stuff - it provides a spray on type rubber finish that is similar to what is applied to pliers handles. It's available at any hardware store, and in various colors. It resists water and acids, and in my tests is not affected by gasoline or brake fluid.

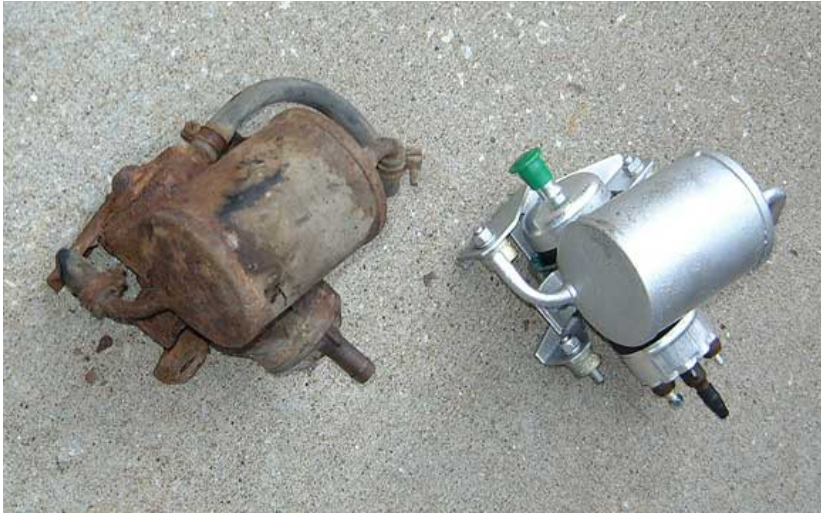
(SEE HOW BAD THEY GET??)

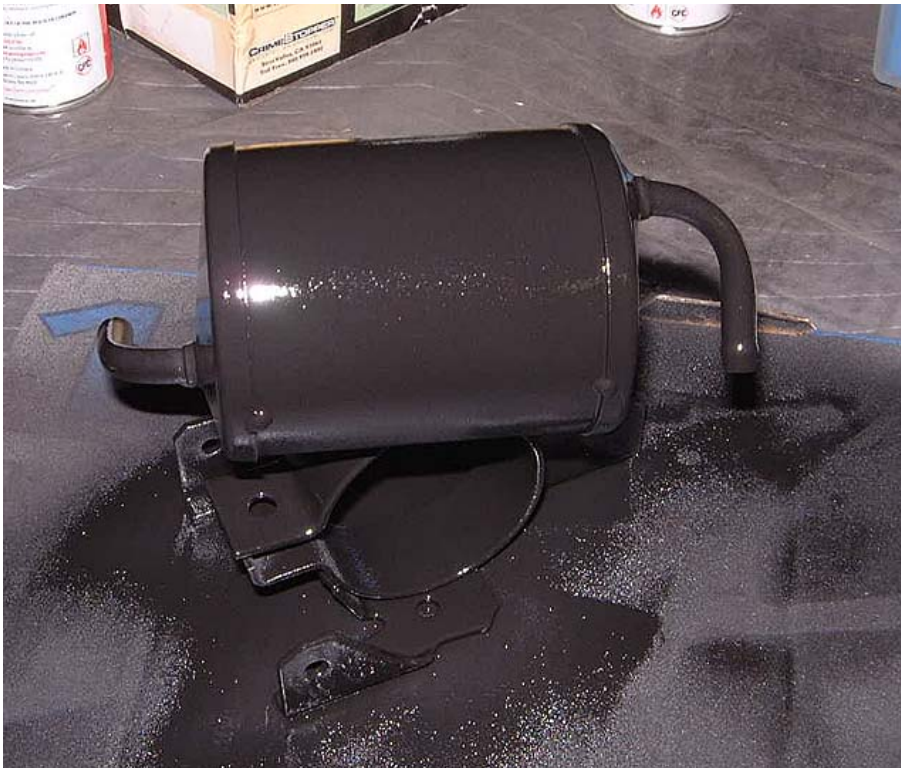
OK, so after I applied a coat of rustoleum over the factory epoxy paint, I started with two coats of this stuff.

You can see in this photo it's rather thick when applied. It does have a good grip also!!!

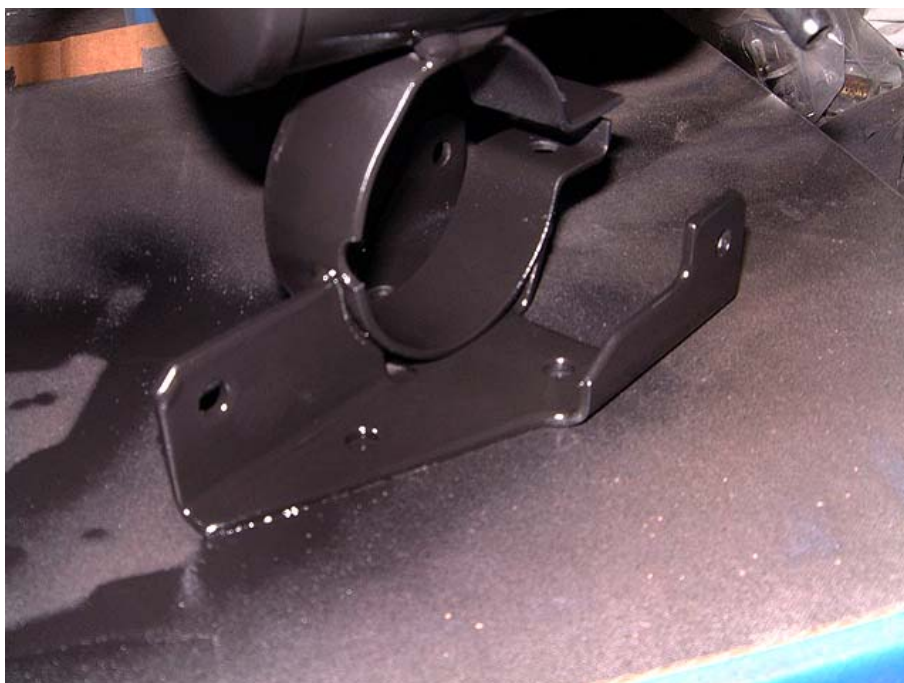
Here it is after the second coat is applied. The color dries to a semi-matte black finish.
